TABLE III-C
SUMMARY OF ANALYTICAL DATA (PCB's)

TABLE III-D
SUMMARY OF ANALYTICAL DATA (PCB's)

CERCLIS/CASE#: FY90-3319

TDD#E06-9010-80

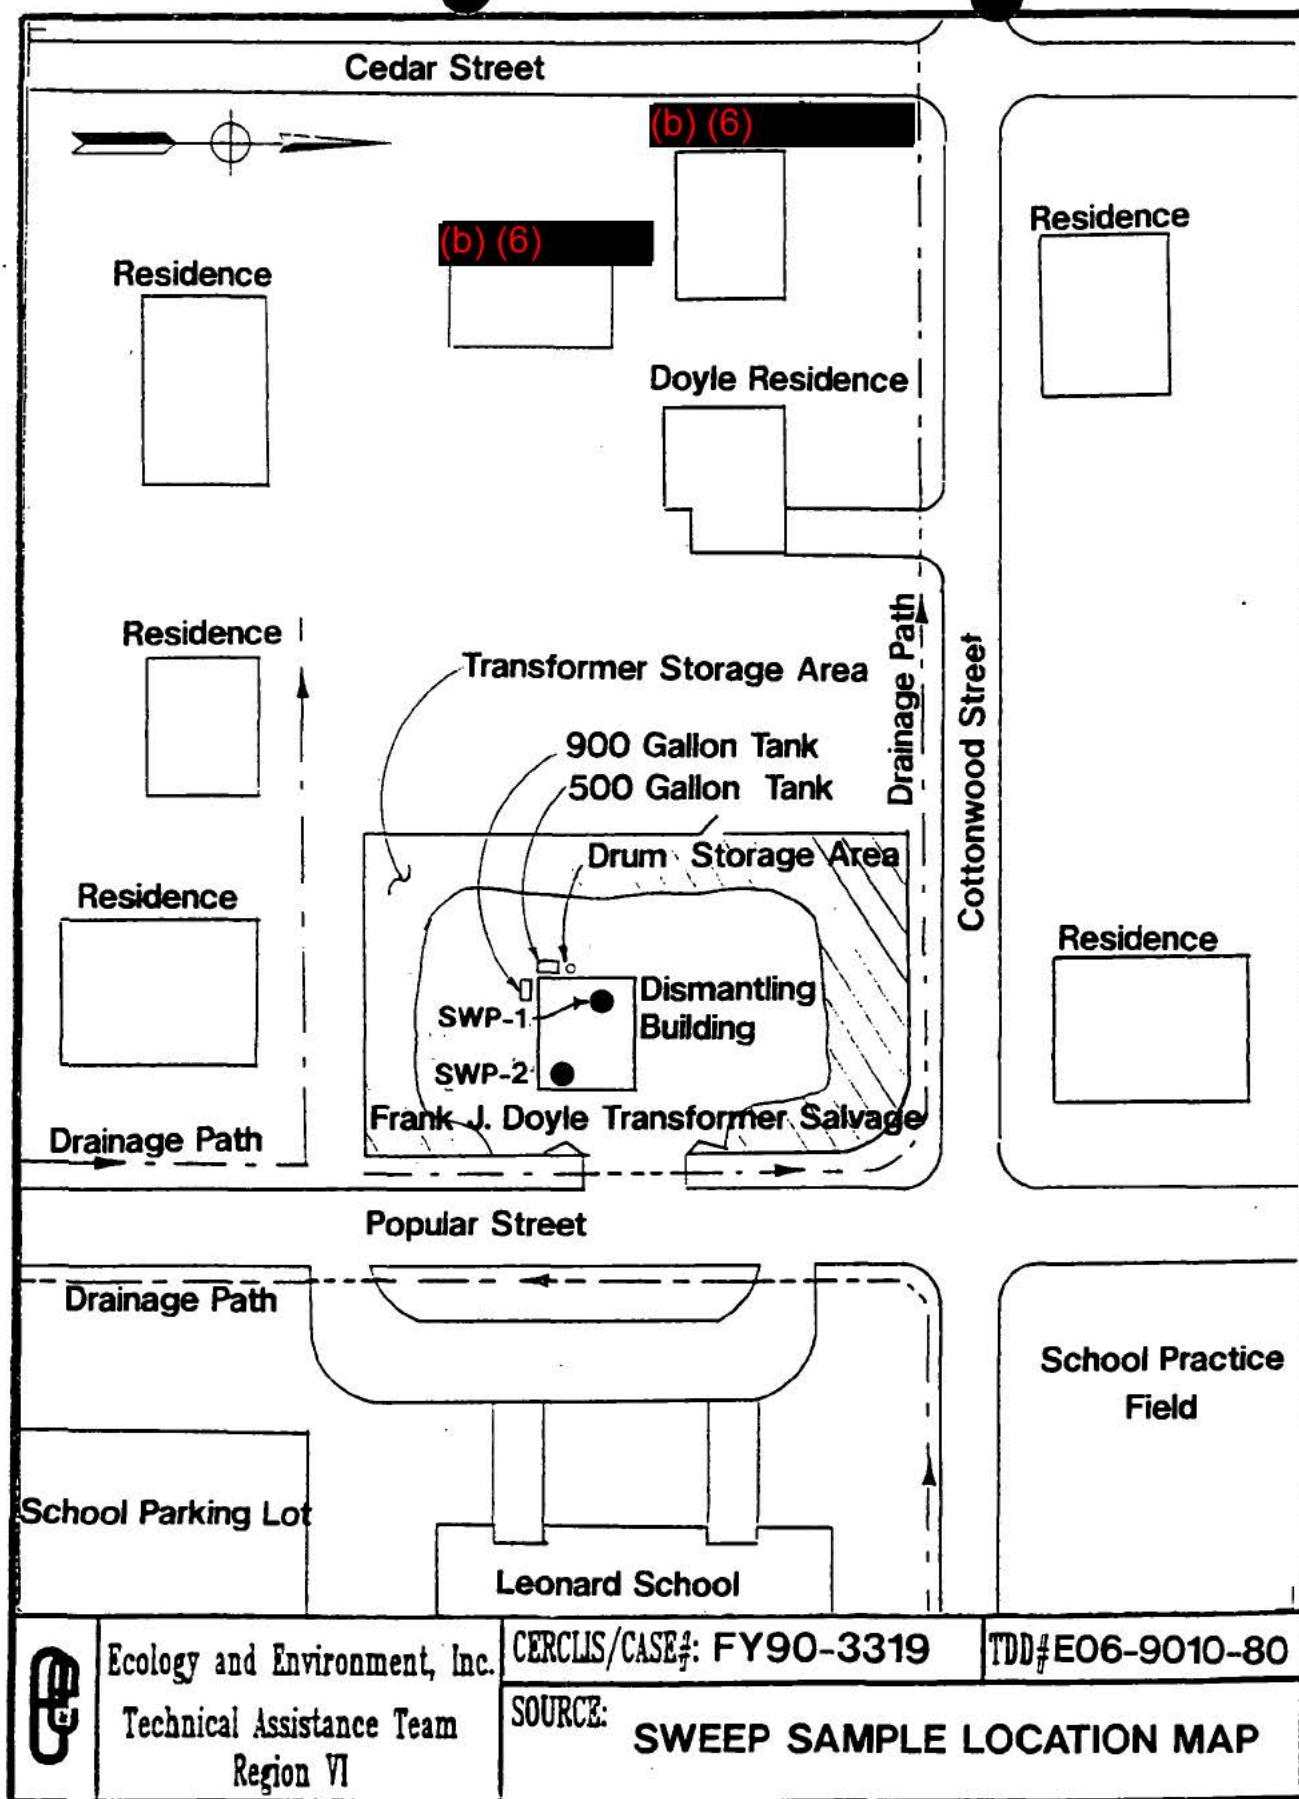
ATTACHMENT C3

Sample #	Locations	Matrix	Concentrations of Aroclor 1260
SAL-S1	Salvage Yard - North Grid	Soil	89.0 ppm
SAL-S2	Salvage Yard - Center Grid	"	41.0 "
SAL-S3	Salvage Yard - South Grid	"	71.0 "
SAL-S4	Salvage Yard - Drum Storage Area	"	10.0 "
SWP-1	Inside Dismantling Bldg-West Side	Sweep	97.0 ug/wipe
SWP-2	Inside Dismantling Bldg-East Side	Sweep	310.0 ug/wipe
DRM-1	Drum at Drum Storage Area	Oil	ND
TNK-1	500 Gallon Storage Tank	"	ND
TNK-2	900 Gallon Storage Tank	"	ND
TRN-1	Transformer From Salvage Yard	"	ND
TRN-2	Transformer From Salvage Yard	"	ND
KLN-W *	Kiln(Inside Dismantling Building)	Wipe	ND

SWEEP SAMPLE LOCATION MAP

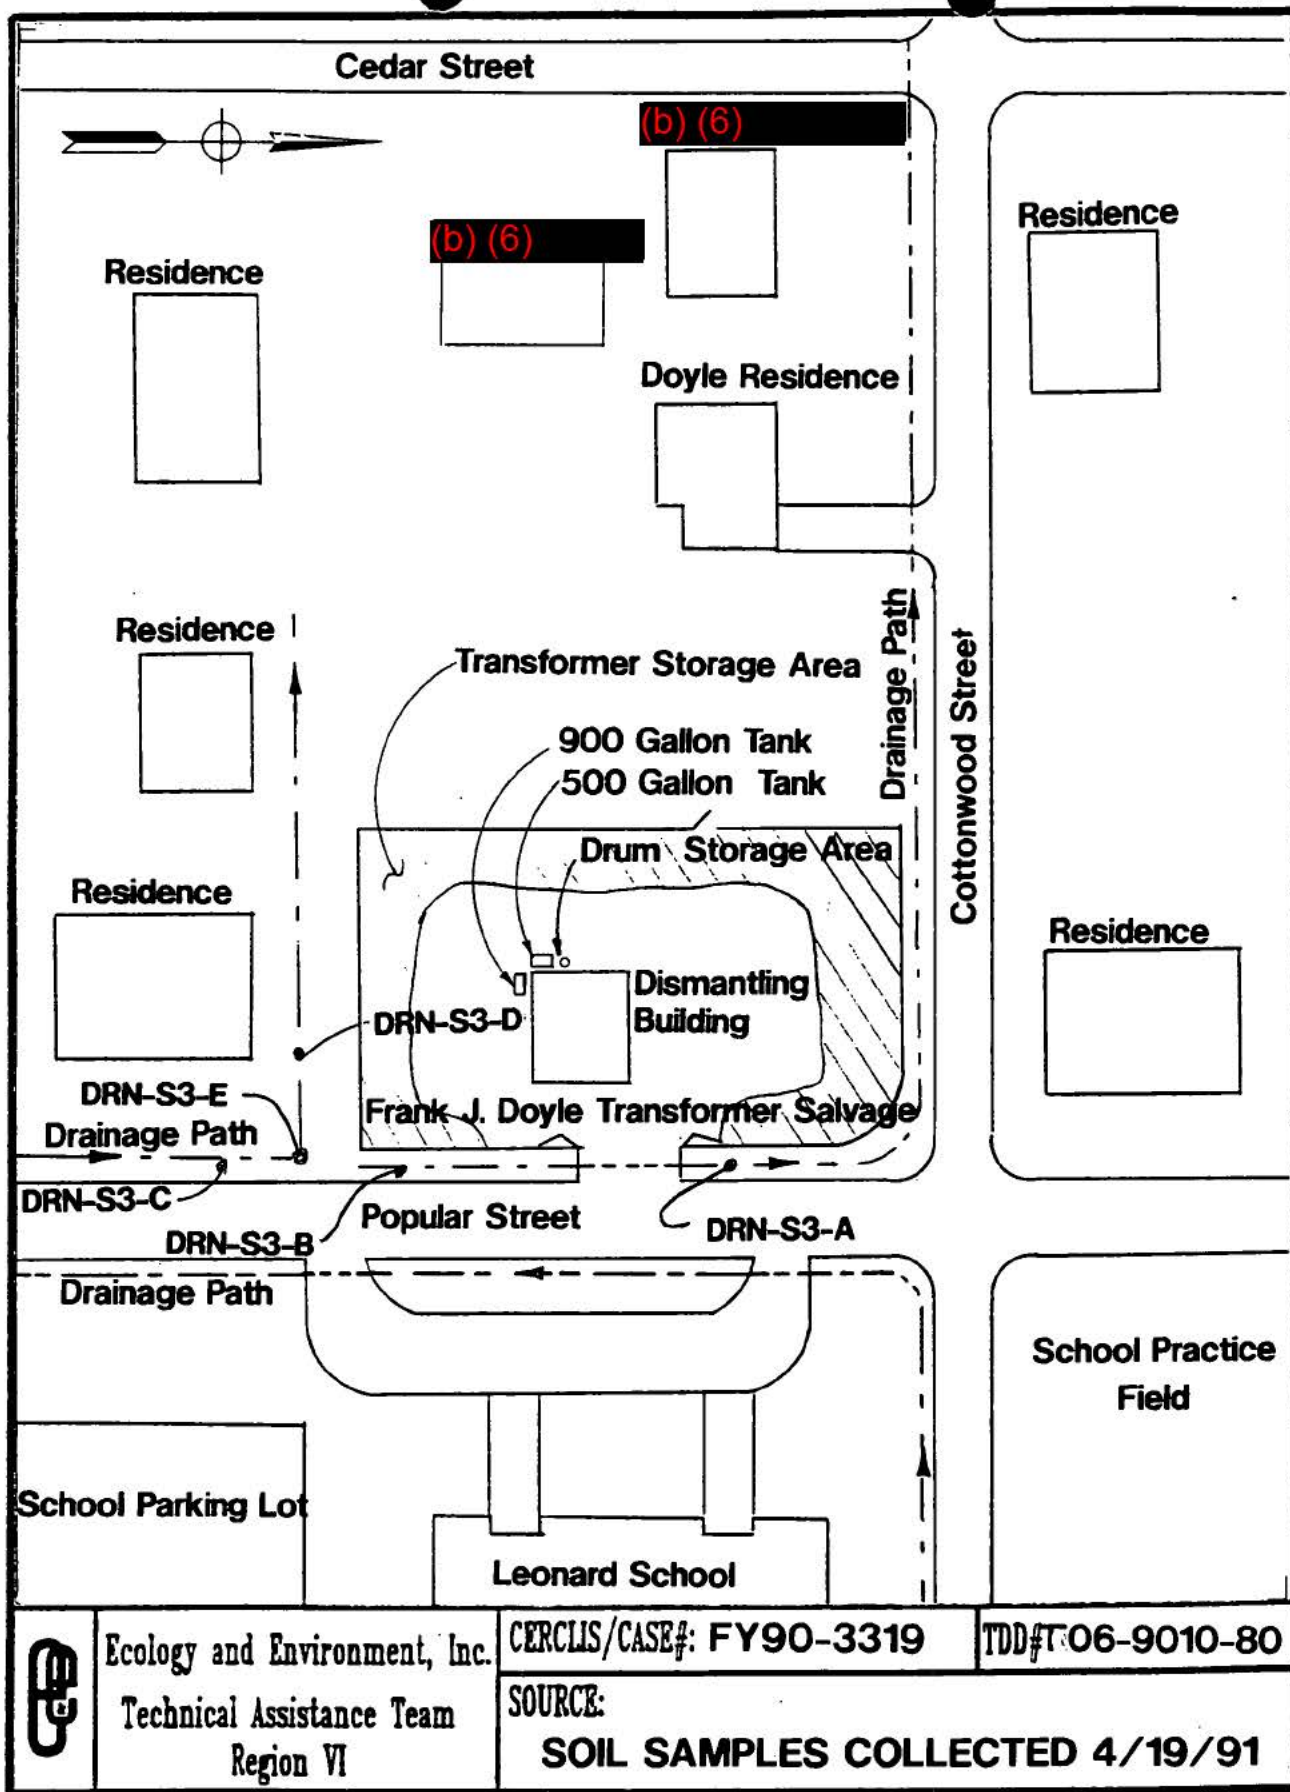
Sample #	Locations	Matrix	Concentrations of Aroclor 1260
DRN-S3A	North East Drainage Ditch	Soil	58.0 ppm
DRN-S3B	South East Facility Drainage	"	6.2 "
DRN-S3C	South East Drainage	"	7.0 "
DRN-S3D	South Drainage	"	271.0 "
DRN-S3E	Grab Sample	"	166.0 "

SOIL SAMPLES COLLECTED 4/19/91
